Pentium® III Xeon™ Processor Specification Update

Release Date: August 1999

Order Number: 244460-005

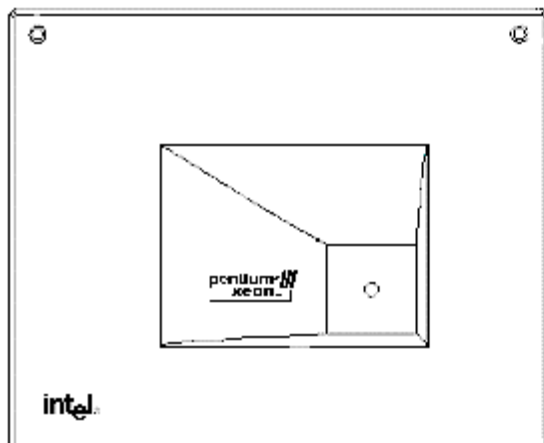
Pentium® III Xeon™ and Boxed Pentium® III Xeon™ Processor Markings

Production Dynamic Mark Example:

500/512/100/2.0V S1
 FFFFFFFF-NNNN {country}
 i®©'98 SSSSS

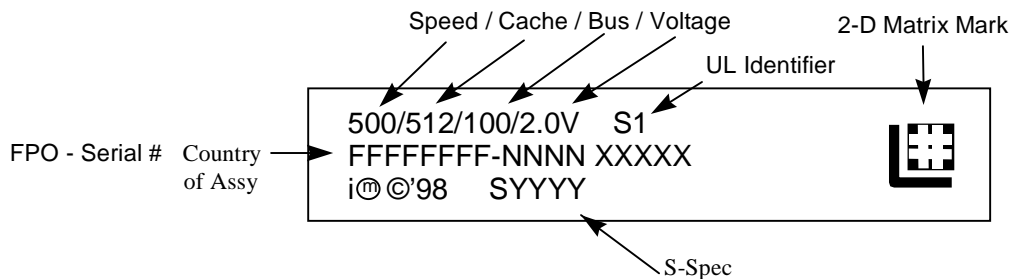
Dynamic Mark Area

Intel 80525PY500512
 FFFFFFFF-NNNN
